Failure of the Trailing Umbilical System Disconnect Actuator on the International Space Station

Abstract

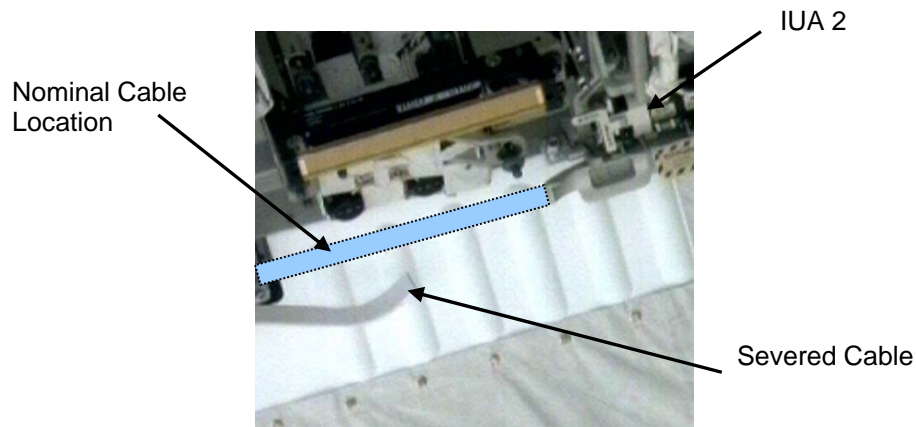
On December 16, 2005, a power switch on the ISS was tripped by a short circuit. Video of the MT and Trailing Umbilical System (TUS) cable revealed the cable routed to Interface Umbilical Assembly (IUA) 2 on the nadir side of the MT had been inadvertently severed (see Figure 1). When the cable was severed the live wire tips contacted metal causing a short, leading to a tripped power switch. Commanded actuation requires three independent power switch closures to the TUS Disconnect Actuator (TDA), and telemetry analysis indicated no possible electrical cause. The only remaining cause of the severed cable was a mechanical failure of the TDA.

Figure 1. Severed TUS Cable on IUA 2

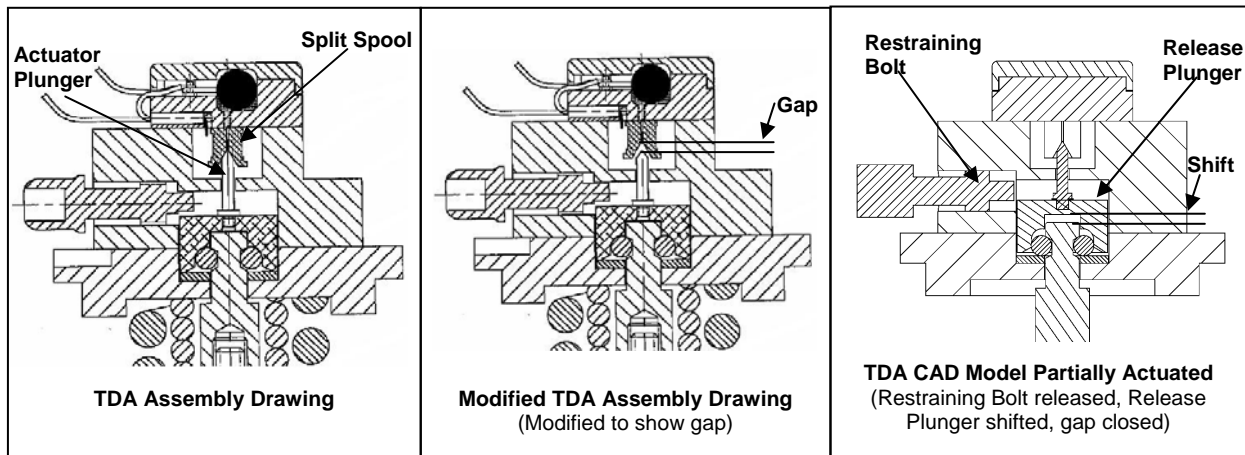
An assessment of the design was performed to determine what effects the as-built hardware could have on the position of the components within the mechanism. The results of the assessment indicated that when the components were built to the nominal drawing dimensions a gap would exist between the Actuator Plunger and Split Spool. If the as-built components were biased to one side this could increase that gap. The TDA assembly drawing omits this gap (see Figure 5).

During assembly of the flight units, the top portion of the T-plunger is installed and the Release Plunger with Retaining Pins is compressed. Next, the Restraining Bolt is engaged to hold the Release Plunger in place and preclude release of the top portion of the T-plunger. The Primary Compression Springs are then mechanically compressed, and the bottom portion of the T-plunger is installed and fastened to the top portion with a single bolt. The final step installs the TDA Cover with Split Spool to the Housing. After reviewing the assembly process it was clear that any gap between the Actuator Plunger and Split Spool would go undetected during final assembly of the flight unit. That gap is maintained by the Restraining Bolt until the unit is activated on-orbit. During on-orbit activation the Restraining Bolt is removed and the Release Plunger would move to close the gap (see Figure 5).

Figure 5. Gap Illustrations

Cross sections of the TDA assembly drawing show a close fit between the Split Spool and the Actuator Plunger and a gap between the Restraining Bolt and Release Plunger. As-built assembly indicated a gap at the Split Spool and a closed gap at the Restraining Bolt to Release Plunger interface, as seen in Figure 5, leaving the TDA partially actuated and changing the load path.

A detailed design study and resting state review considering the impacts of spring forces would point out the possibility of these issues and their impact to loading within the mechanism. Defining critical dimensions for Split Spool and Actuator Plunger height to ensure the Restraining Pins would remain fully seated could prevent a gap and the associated high loading condition.

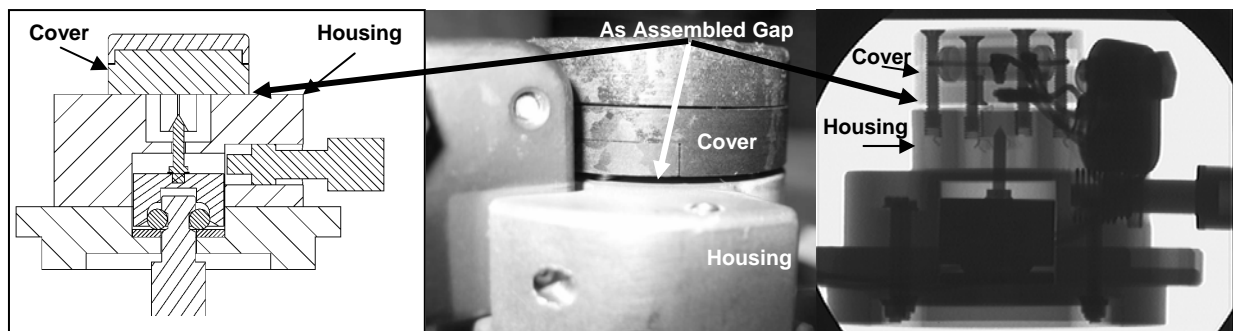
Upon return of the failed TDA, disassembly and non-destructive evaluations were performed. The first was an x-ray of the TDA Housing and internal components to determine whether or not the Restraining Wire and Fuse Wire were still intact. In addition, a detailed survey was performed of the exterior of the TDA Housing and Cover. Since the TDA mechanism was actuated and disassembled from the IUA on-orbit, the T-plunger and spring dimensions and surfaces could also be inspected. The x-ray of the TDA Housing clearly showed the Restraining Wire and Fuse Wire were still intact and did not cause the failure. When the outer covering tape was removed from the top portion of the TDA Cover, a non-uniform gap nearly 1.02 mm (0.04 in) tall was found between the Cover and Housing, indicating an assembly error. This gap was also confirmed by a subsequent review of the x-ray. The markings on the removed tape were consistent with a gap that had been present from initial Cover installation.

Figure 6. Failed TDA External View (tape removed) & X-Ray

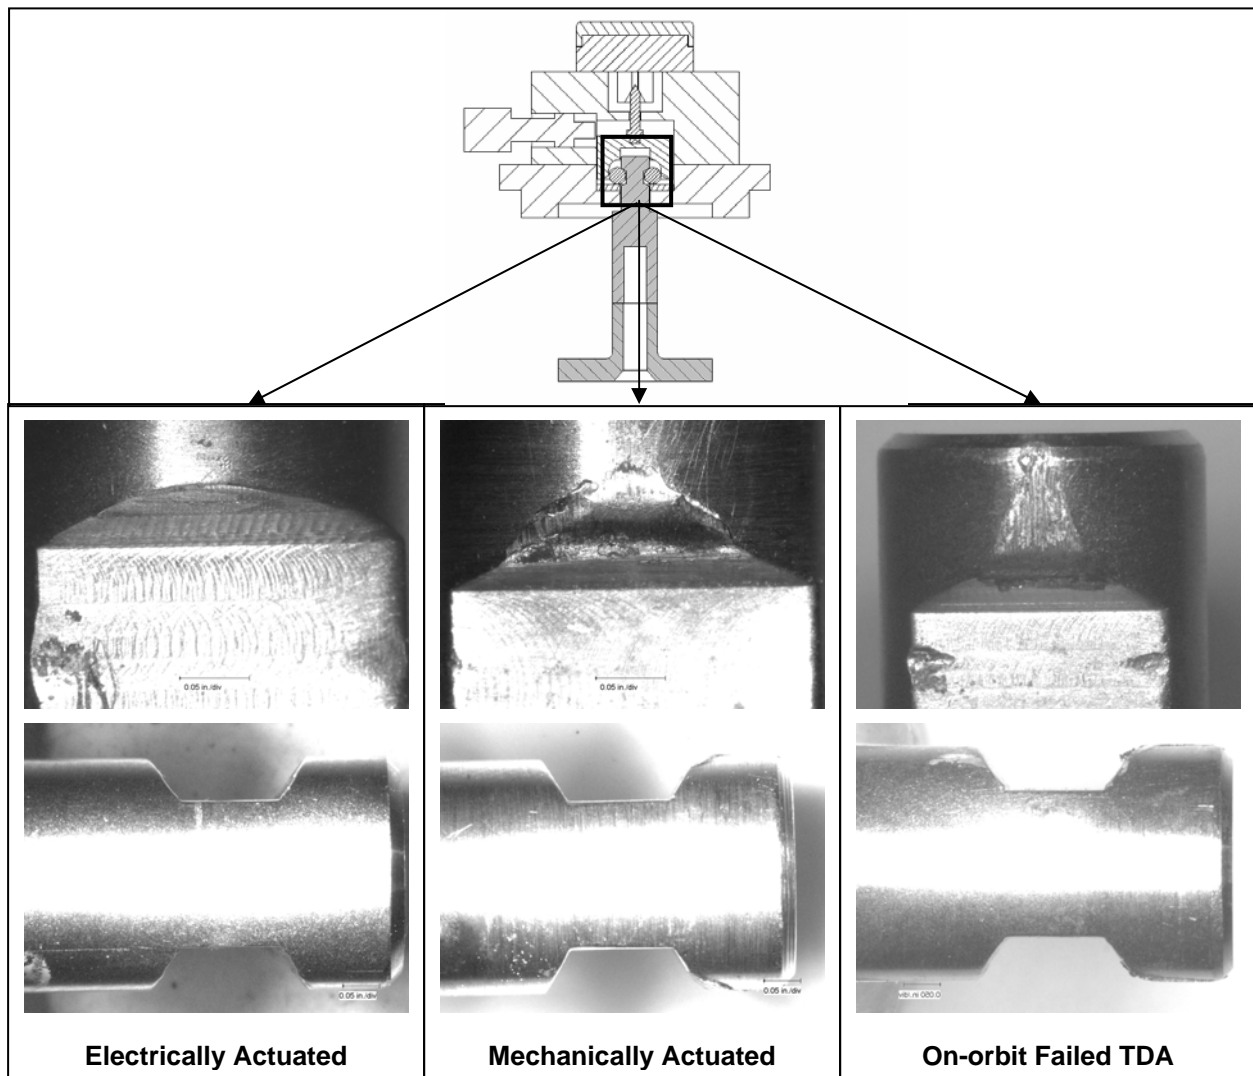
Upon inspection of the T-plunger, yielding was found where it contacted the Retaining Pins. Prior to obtaining the failed TDA, a series of ground tests were performed to support the planned on-orbit repair strategy. These tests included both a slow mechanical release of the Actuator Plunger and a near instantaneous release of the Actuator Plunger. Mechanical actuation was achieved by slowly backing out the fasteners that hold the Cover and Split Spool to the Housing, thus allowing the Release Plunger to shift and release the T-plunger. This test resulted in three findings that were significant to the failure investigation: 1) The T-plunger release required significantly less travel than expected (~ 0.965 mm (0.038 in) actual vs. ~ 4.75 mm (0.187 in) expected), 2) The edge of the T-plunger notch was mechanically yielded at the Release Pin interface, 3) The Split Spool was damaged at the Actuator Plunger interface. Post flight inspection of the failed TDA T-plunger indicated similar notch yielding at the Retaining Pin interface. The travel required to mechanically actuate the TDA was similar to the gap that was seen between the Cover and the Housing on the failed TDA. This indicates the TDA was very close to actuating when the Restraining Bolt was first removed on-orbit.

Figure 7. T-Plungers Post Actuation

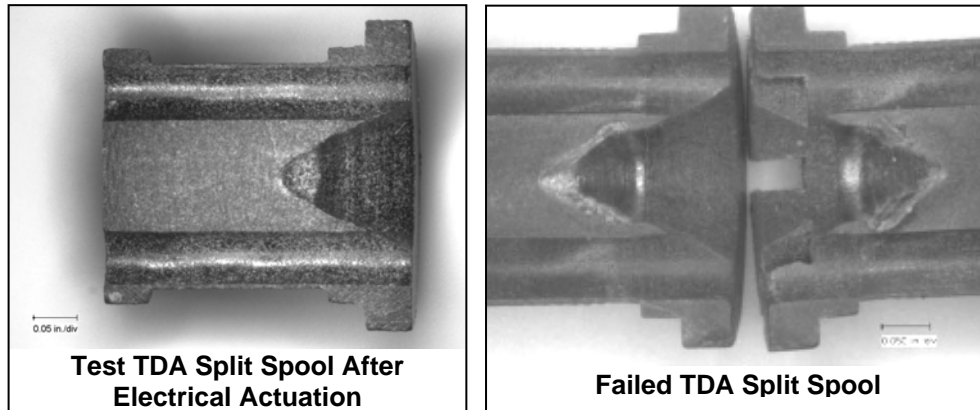
The Split Spool and Restraining Wire were inspected via x-ray and visually after initial disassembly. The Restraining Wire was intact and did not allow the Split Spool to separate. The Split Spool was then separated by removing the Restraining Wire to allow a detailed inspection of the Split Spool halves. The inspection revealed the Release Plunger had compressively yielded the interior of the Split Spool. This finding was consistent with the damage seen during the mechanically actuated ground test. This damage is caused by an increased force transferred to the Actuator Plunger from the Primary Compression Springs during a slow release actuation. As the Release Plunger travels upward the Primary Compression Springs force the Restraining Pins outward. This outward force is then transmitted to the Release Plunger and subsequently to the Split Spool. When the TDA is electrically actuated the Split Spool is free to separate and thus does not compressively yield (see Figure 8).

Figure 8. Split Spool Details

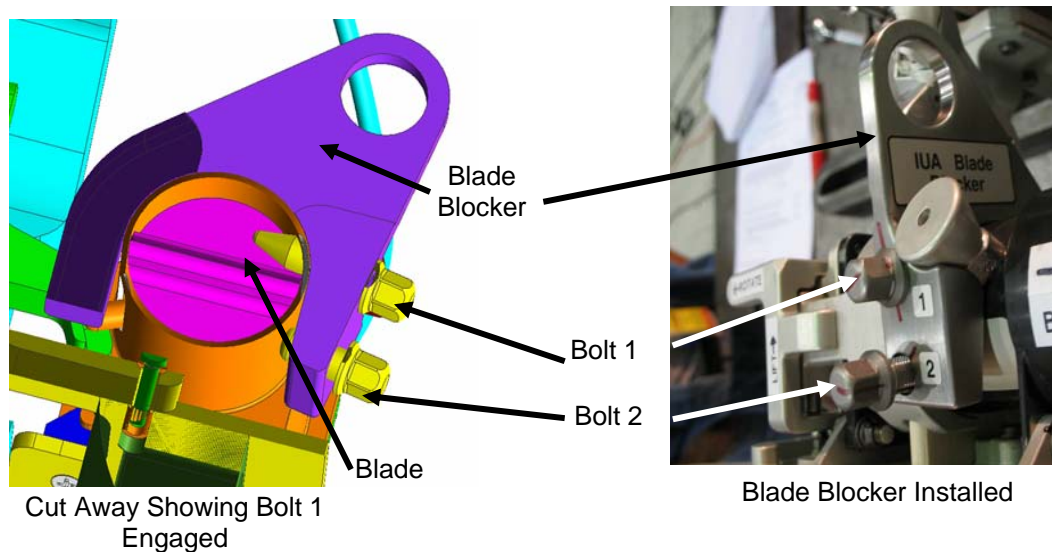
Figure 9. Blade Blocker Details

In the weeks after the TUS 2 cable sever, the team was concerned with the possibility of a second TDA failure on IUA 1 leading to a TUS 1 cable sever. In early February 2006 during Russian Extravehicular Activity (EVA) 15, the TUS 1 cable was routed outside of the TDA to prevent it from being cut until a long term repair could be implemented. The configuration of the MT leading up to the removal of the failed system was the TUS 1 cable was severed (IUA 1 failed) and the TUS 2 cable was routed outside of the TDA. The team prepared a repair to regain full MT redundancy in one Shuttle Flight, STS-121 (ISS Mission ULF1.1), in July of 2006. One requirement was to fly a spare TUS Reel containing a fully intact cable with connectors. In addition, the blade blocker (see Figure 9) was designed and tested on the ground to be installed EVA onto IUA 1 to prevent the TDA from cutting the cable in the case it too mechanically failed. The repair allowed for IUA 1 to be fixed in place in one short EVA task.

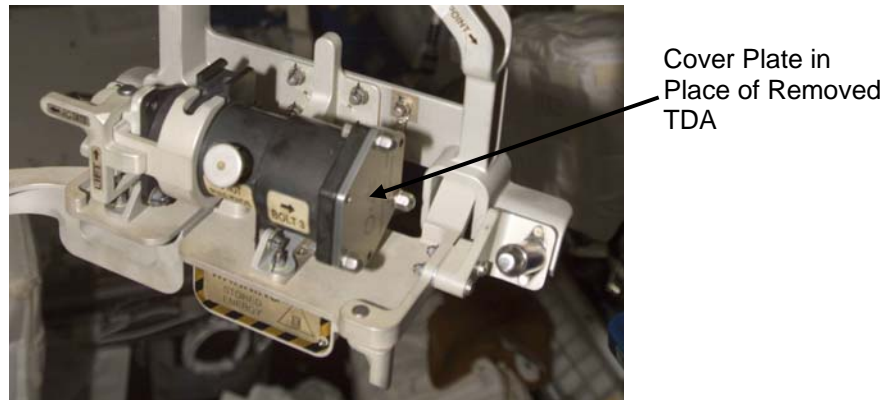
Figure 10. New IUA Configuration

Next was to address both the ground spare and the failed IUA 2 on-orbit. For the ground spare the TDA hardware was removed to prevent inadvertent actuation once in service. The IUA itself is still required for power conditioning, TUS cable to MT interface connections, and cable strain relief. This modified spare unit was installed in place of the failed IUA 2 during the STS-121/ ISS ULF1.1 mission. With the removal and replacement (R&R) of the TUS 2 Reel, installation of the blade blocker onto the IUA 1, and R&R of IUA 2 with the newly configured spare, the MT System was left with full redundancy at the end of the mission. In a subsequent decision, the ISS Mission Management Team decided the crew would disassemble the failed TDA on-orbit and only return that small portion to the ground for failure investigation. The failed IUA 2 was re-configured much like the spare unit during the mission and now serves as a fully operational IUA spare on-orbit without any ground re-processing required. Figure 10 illustrates the configuration of a newly configured IUA.

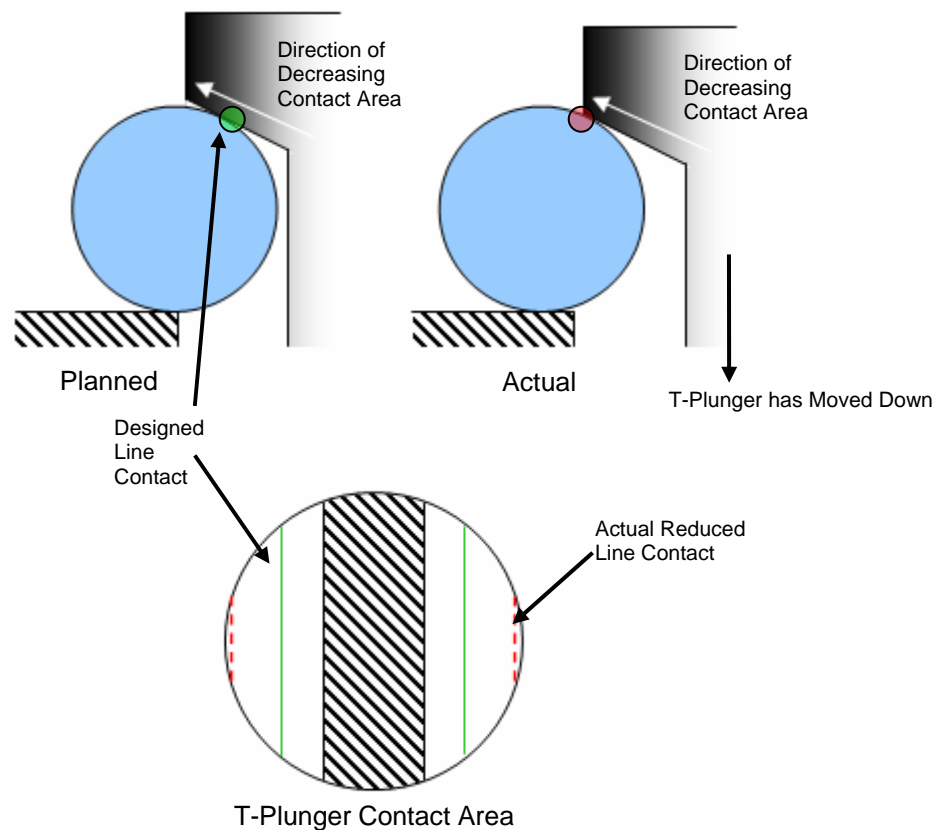
Creating a gap between the Actuator Plunger and the Split Spool allows a partial actuation of the TDA when the Restraining Bolt is removed. The effect of creating that gap is movement of the Retaining Pins along the slope of the T-plunger, as shown in Figure 10. When this loading condition is created, the high force from the Primary Compression Springs is concentrated on a significantly smaller area within the TDA. The designed line contact reduces greatly as it approaches a point contact as shown in Figure 10. Any yielding at that point exacerbates the problem and further actuates the TDA.

Figure 10. Change in Load Condition at Retaining Pin

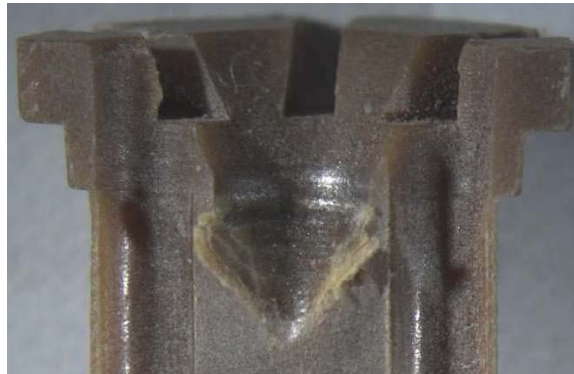
Disassembly of the Cover portion of the TDA assembly revealed deformation and yielding of the Split Spool (see Figure 11). Torlon Split Spools of this type had been used previously in switches for power systems.

Figure 11. Split Spool Deformation

In other applications, Torlon was highly desirable because of its electrical insulating properties. For the TDA, electrical properties were irrelevant. Structure focused requirements for this portion of the TDA would have weighted strength as far more important than electrical resistance. Torlon would not be as robust as steel for this application. Since electrical resistance was irrelevant, a steel Split Spool would be a more desirable choice for a compressively loaded structural member.

Where mechanical and strength properties are the main requirement, they should be weighted more heavily than flight history or other concerns. If the Split Spool was never overloaded, polymer selection would not have been a problem. In this case, other issues led to structural members experiencing loads in excess of design loads and failed by yielding. Caution should be used whenever adapting heritage designs that were developed for other applications.
